In-situ heat transfer performance and durability assessment of GeoHex developed coatings

Development of amorphous metals for corrosion resistant thin film coatings

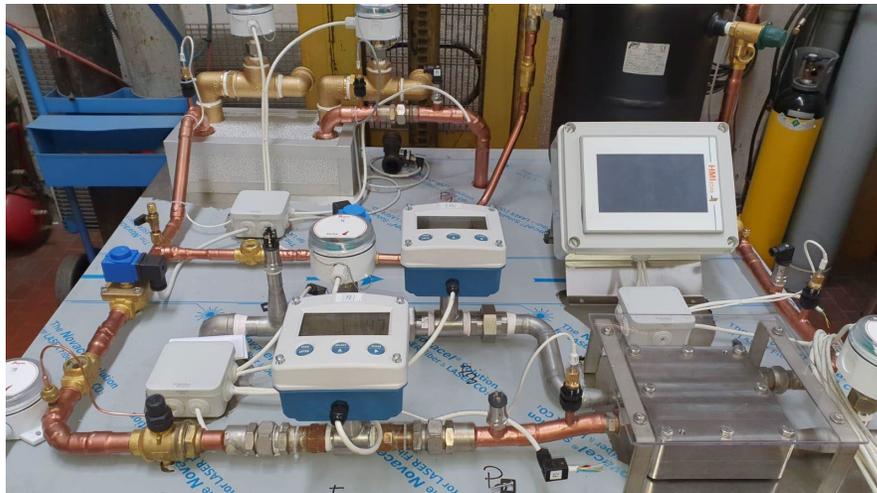
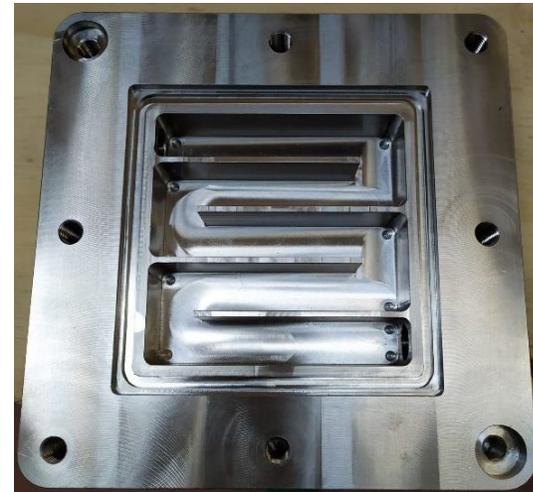
Test rig

- Located at Hellisheiði geothermal power plant.
- Geothermal brine used from separator water, 1st flash
- Short testing: 24 hours
- Long testing: 200 hours

Pressure (bar-g)	8.4
Temperature [°C]	172
pH	8.7
Temperature @pH	26
CO2 [mg/kg]	30
H2S [mg/kg]	50
SiO2 [mg/kg]	676
Na [mg/kg]	206
K [mg/kg]	35
Ca [mg/kg]	0.74
Mg [mg/kg]	< 0.05
Fe [mg/kg]	0.05
Al [mg/kg]	1.7
SO4 [mg/kg]	16
Cl [mg/kg]	186
F [mg/kg]	1.15
